OBSERVATION REPORT

PROJECT: Veterans Memorial Project #929

LOCATION: Saline County Courthouse
Wilber, Nebraska

DATE: July 27 and August 4, 2011

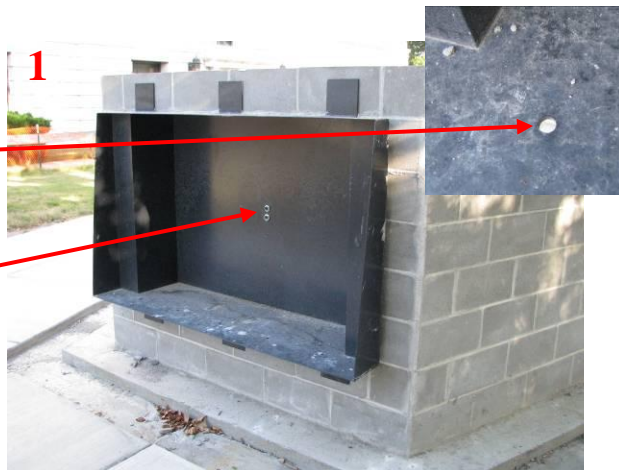
There are holes drilled through the bottom of the steel box to allow moisture to drain.

The steel box has two conduits fed to it, one for power and the other for data cables. The cables will not be installed until the final kiosk is selected in the next phase.

View of the steel box for the kiosk and the weep holes in the bottom face of the box.

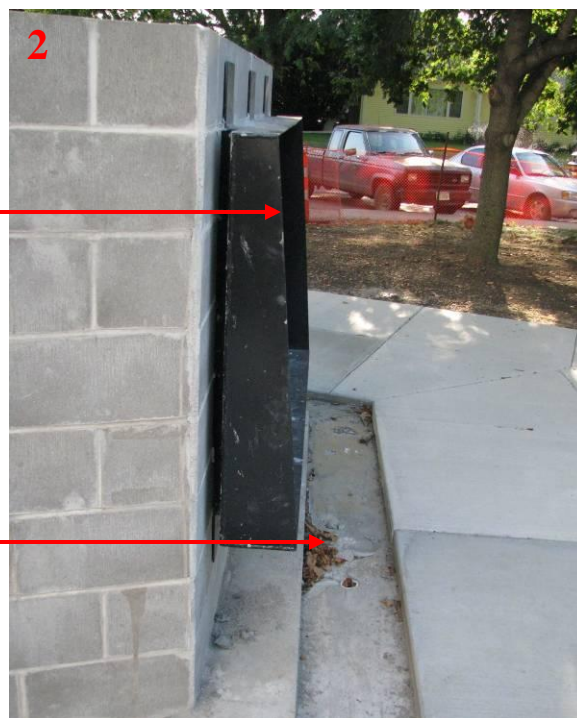
The edge of the box is tapered to stay just inside the edge of the brick veneer that will be laid.

The trench shown here will be filled with brick pavers that will match the bricks used on the walls of the memorial.

Side view of the steel box showing taper for the brick veneer profile.

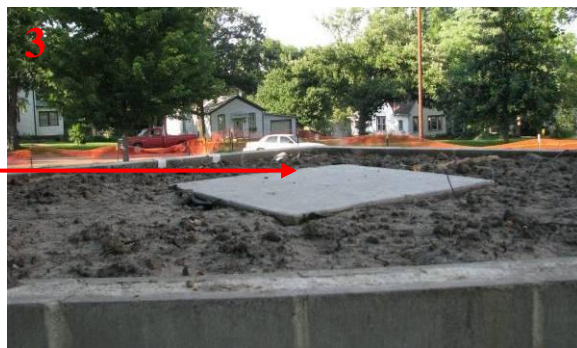
The concrete foundation for the obelisk was poured solid. The holes for the steel pins in the obelisk were drilled just prior to installation, see photo #8.

View of the obelisk base on the top of the memorial.

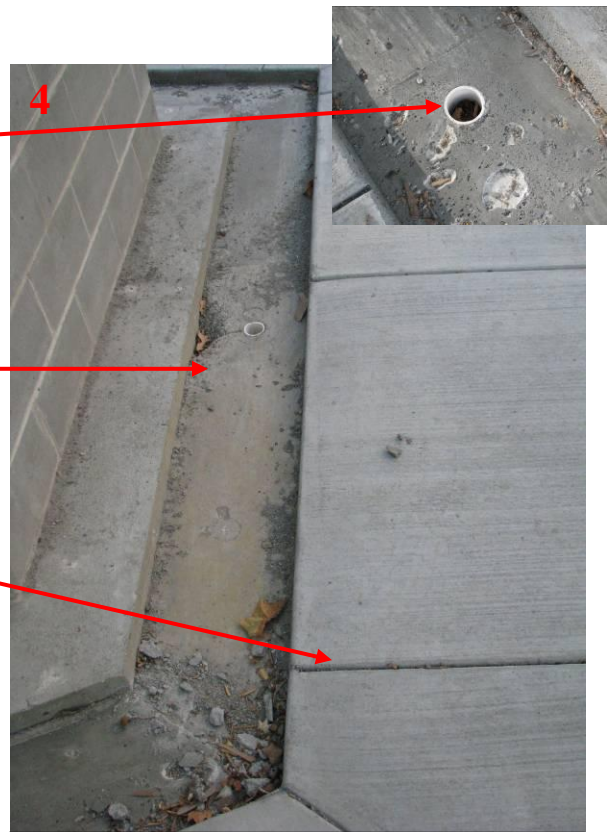
PVC sleeves were added to the trench for the brick pavers in order to allow moisture to drain.

The trench for the brick pavers goes around all five sides of the central pentagon.

Control joints have been created in the concrete as specified.

View of the slot for brick pavers and the weep holes in the base for drainage.

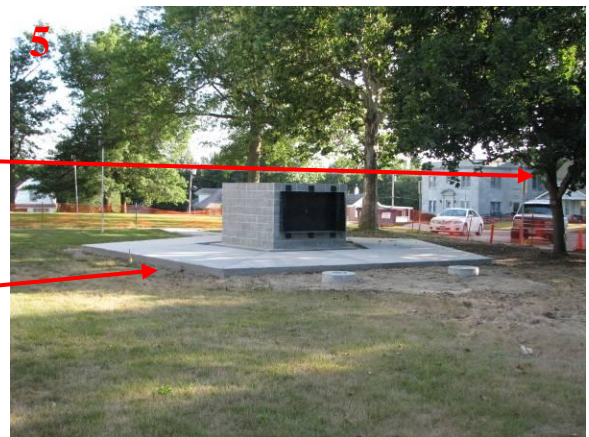
A limb will need to be removed from the maple tree in order to get the flag poles and lights installed.

The final grading will also need to be done prior to project completion. The dirt and regrading is included in the contract, but mulch/landscaping is not.

View of the memorial from the northeast.

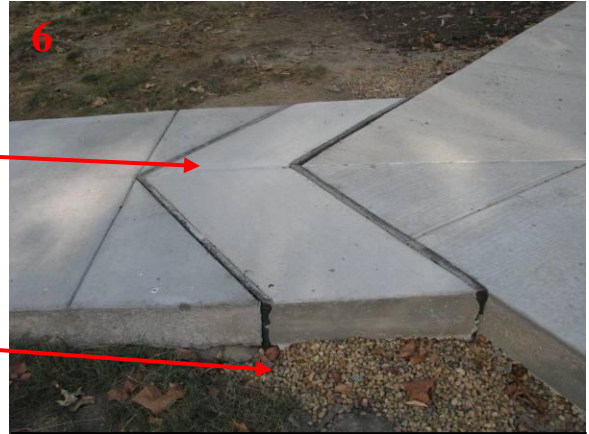
This section of concrete has been designed to be removable, so that the outer most brick paver band can be added in either Phase II or III.

Top soil still needs to be added at the perimeter of the concrete.

View of the portion of the concrete walk that is removable for future brick paver installation.

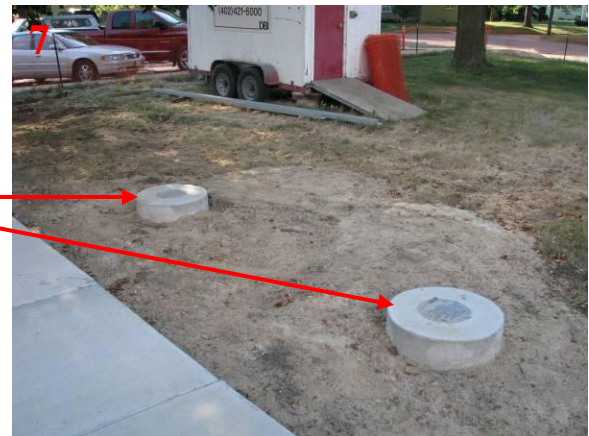
Flag pole bases and sleeves have been installed and are ready to receive the flag poles.

View of the flag pole bases north of the memorial.

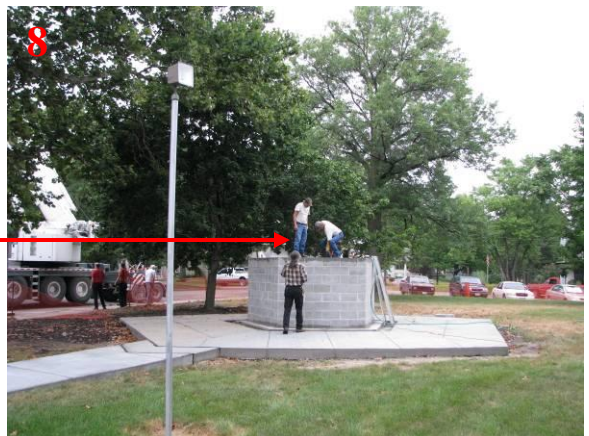
The granite crew core drilled four holes in the obelisk foundation to receive the steel pins that are attached to the bottom of the granite obelisk.

View of the obelisk foundation being prepped for the granite.

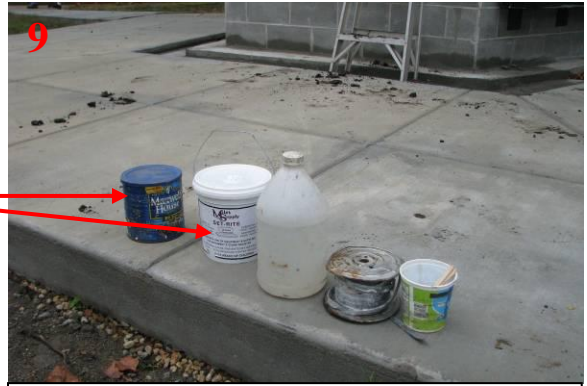
Two types of epoxy were used to set the granite obelisk. Liquid epoxy was used for the holes receiving the steel pins, while putty was used under the main portion of the obelisk base.

View of the epoxy products used to set the obelisk.

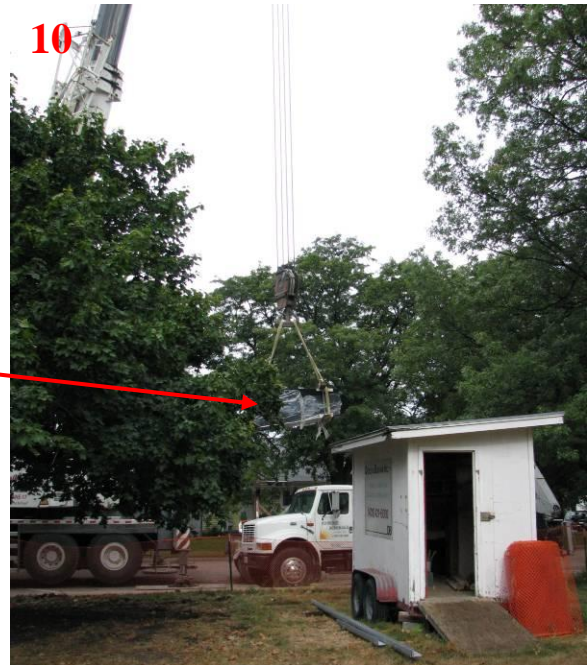
The obelisk was swung off the truck, between two trees and lowered onto a staging area.

View of the obelisk being lifted off the truck.

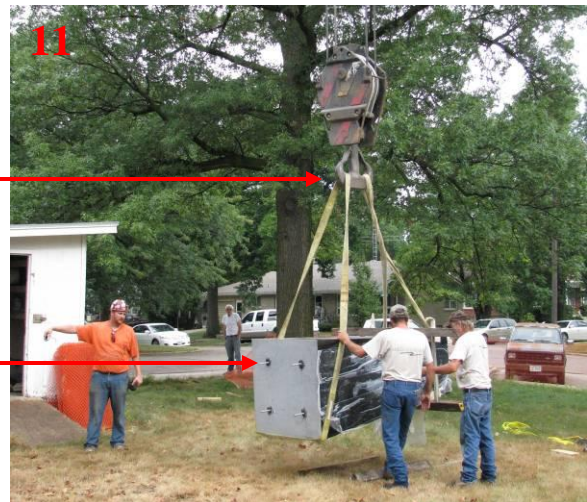
The obelisk was lowered onto a staging area, where the straps were switched in order to rotate the granite upright.

The four steel pins can be seen attached to the bottom of the obelisk in this picture.

View of the obelisk being lowered prior to tipping it upright.

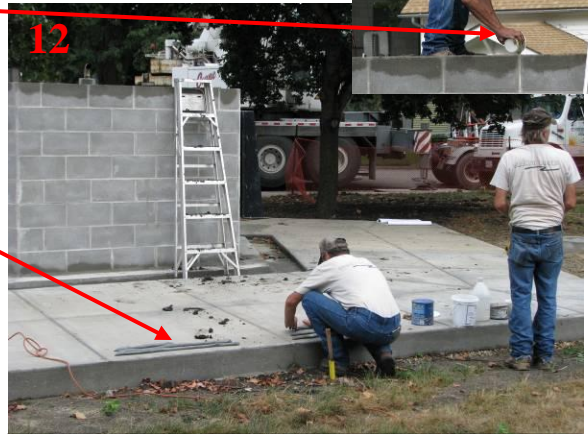
Liquid epoxy was applied to the four holes receiving the steel pins just prior to setting the obelisk.

Putty epoxy was prepped for the flat portion of the foundation and rolled into long strings. These strings were placed around the perimeter of the base and formed a seal between the granite and concrete when the stone was placed.

View of the epoxy preparation and application.

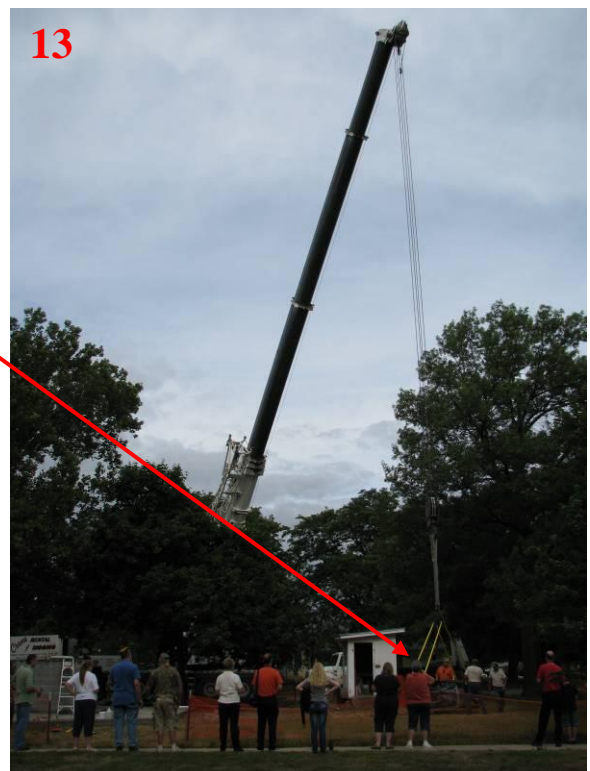
After the straps were switched out on the crane, the obelisk was rocked up into its upright position. The obelisk was then rotated into its final orientation with the combat soldier facing south.

View of the crane as it tips the obelisk into the upright position.

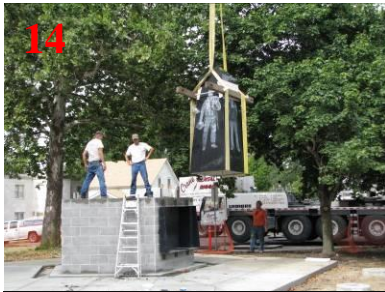
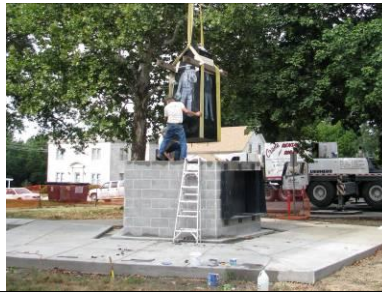
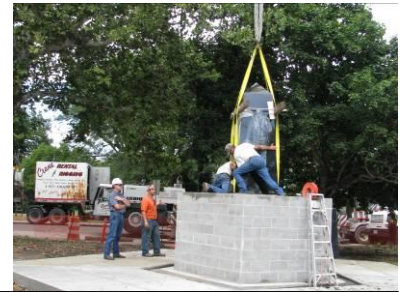
Sequence of photos showing the setting of the granite obelisk.

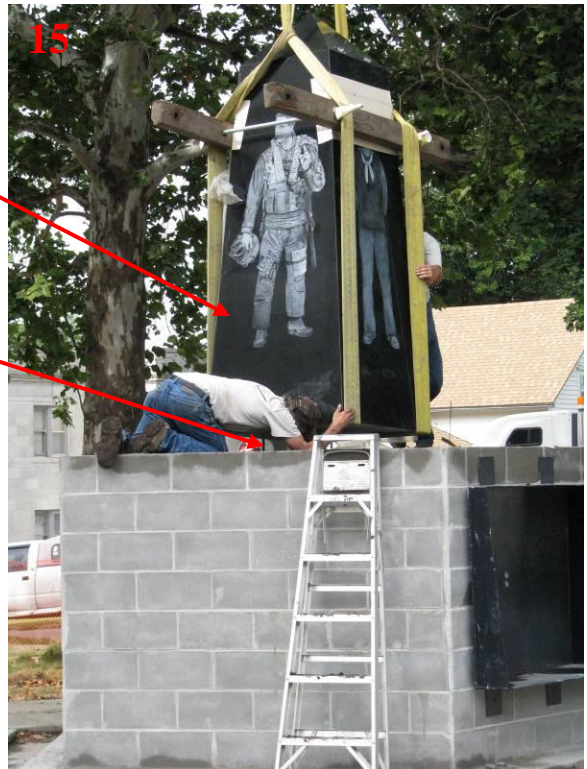
The granite crew guided the granite obelisk into position and lowered the pins into the holes that were drilled in the concrete.

Small lead spacers were installed under the granite to allow the hoist straps to be removed.

View of the workers aligning the obelisk with the foundation prior to final setting.

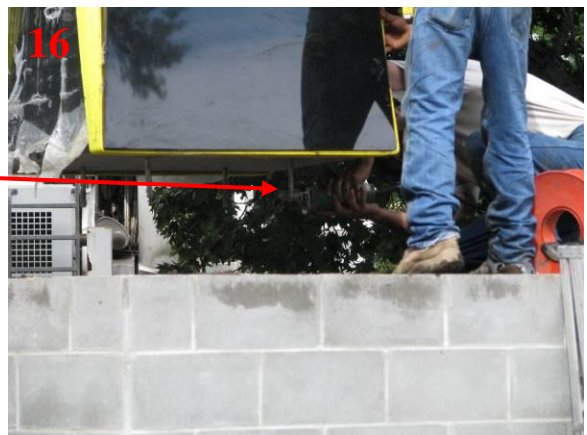
During installation, one or more of the holes did not receive the entire steel pin(s). The obelisk was lifted, and approximately 2" of each pin was cut off prior to resetting the obelisk. Epoxy was reapplied to the holes prior to resetting the obelisk.

View of the workers cutting steel pins under the obelisk.

The concrete foundation was drilled to receive the four steel pins attached to the bottom of the granite. During the installation of the obelisk, the steel pins were interfering with the stone's alignment. The obelisk was raised off of its base, the last 2" of the pins were cut off, and the obelisk was realigned and lowered back onto its base. Liquid epoxy was reapplied to the pin slots

prior to resetting the obelisk. The putty epoxy was also added to the base for keeping water out of the space between the stone and the concrete. The stone then had the protective plastic film removed, and was cleaned by the stone setting crew.

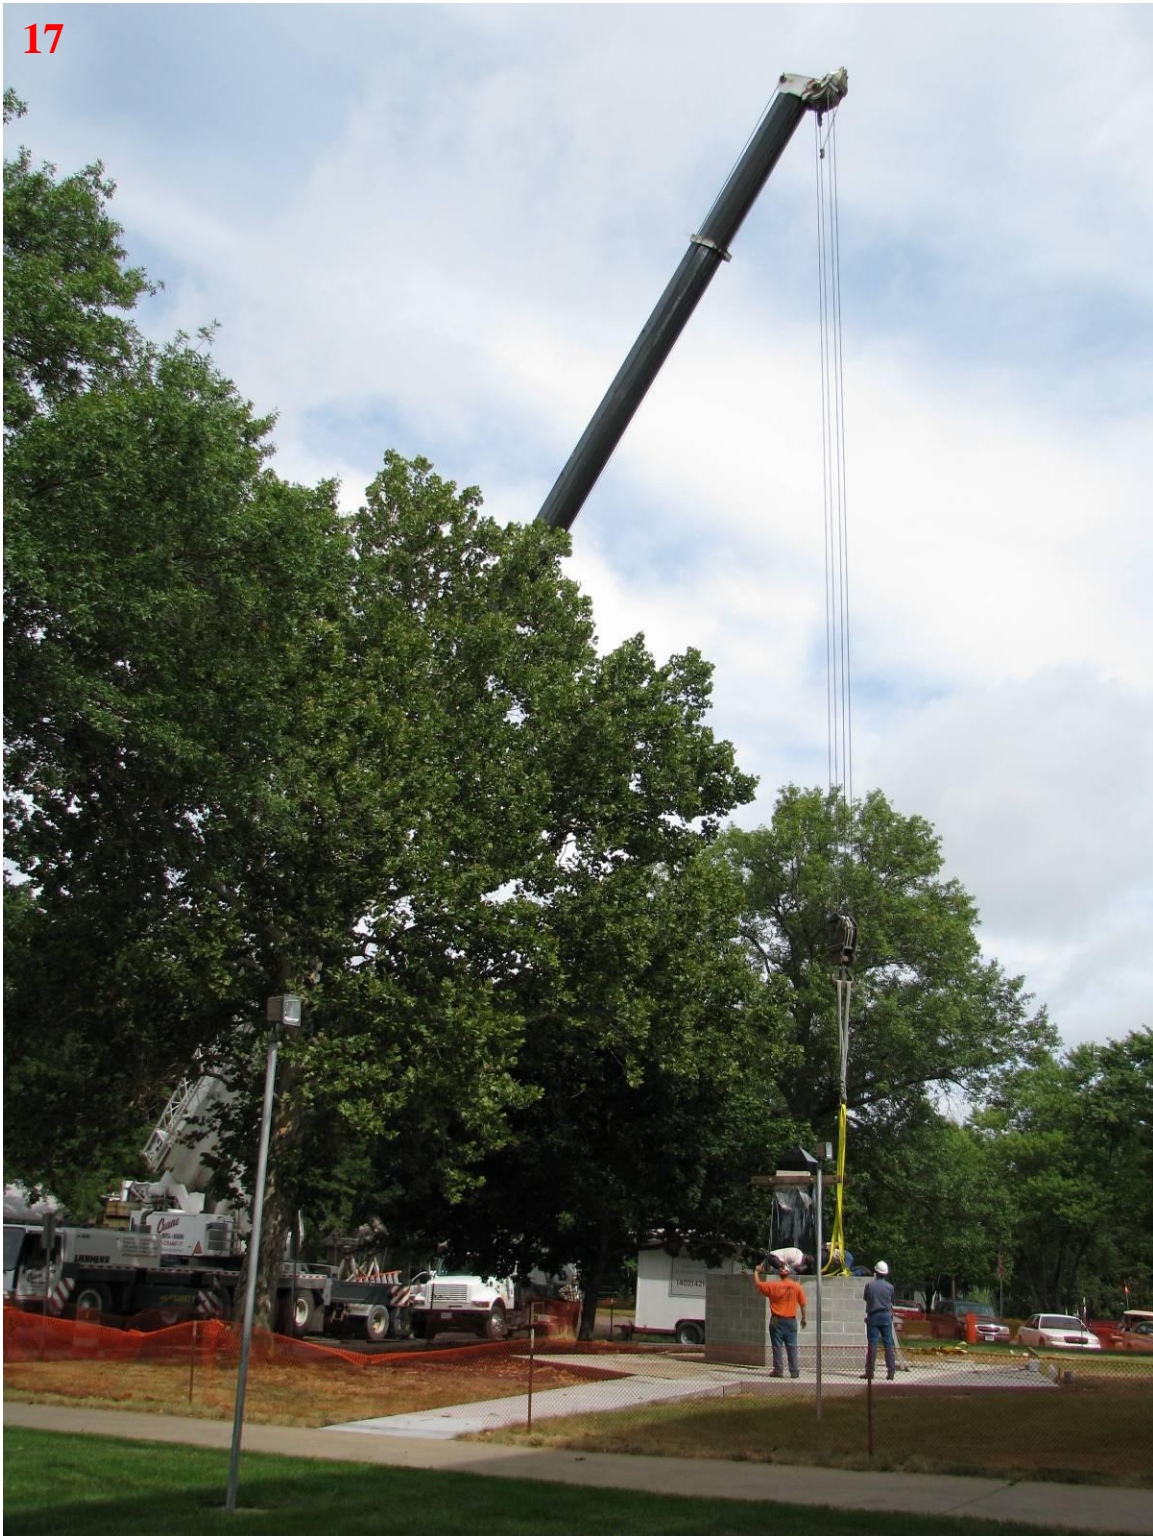
View of the crane and memorial as the obelisk is set into its final location.

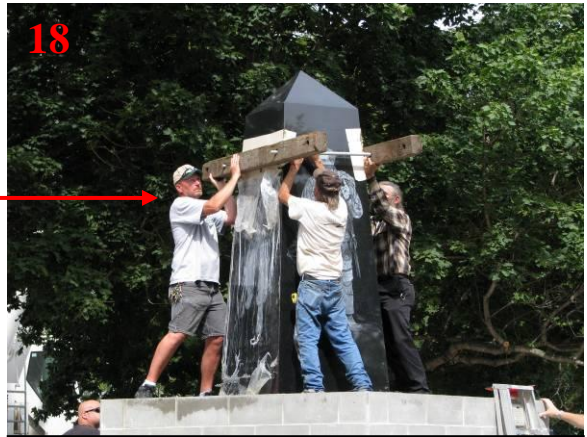
After the obelisk was set, the clamp used for hoisting the stone was removed.

View of the crew removing the clamp from the obelisk.

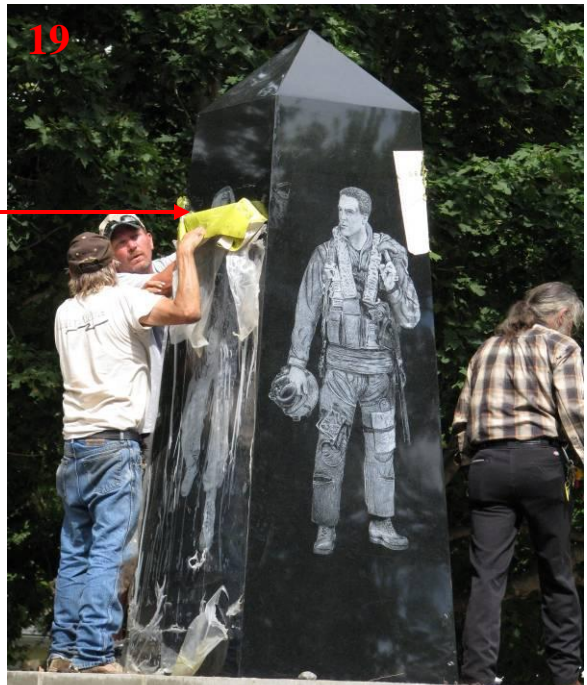
The protective plastic film was then removed from the obelisk revealing the etchings.

View of the crew removing the protective plastic film from the etchings on the granite.

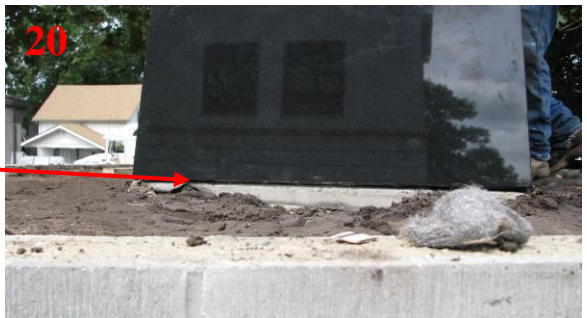
A clean tight fit was achieved between the granite and concrete foundation.

View of the obelisk where it sits on the concrete foundation.

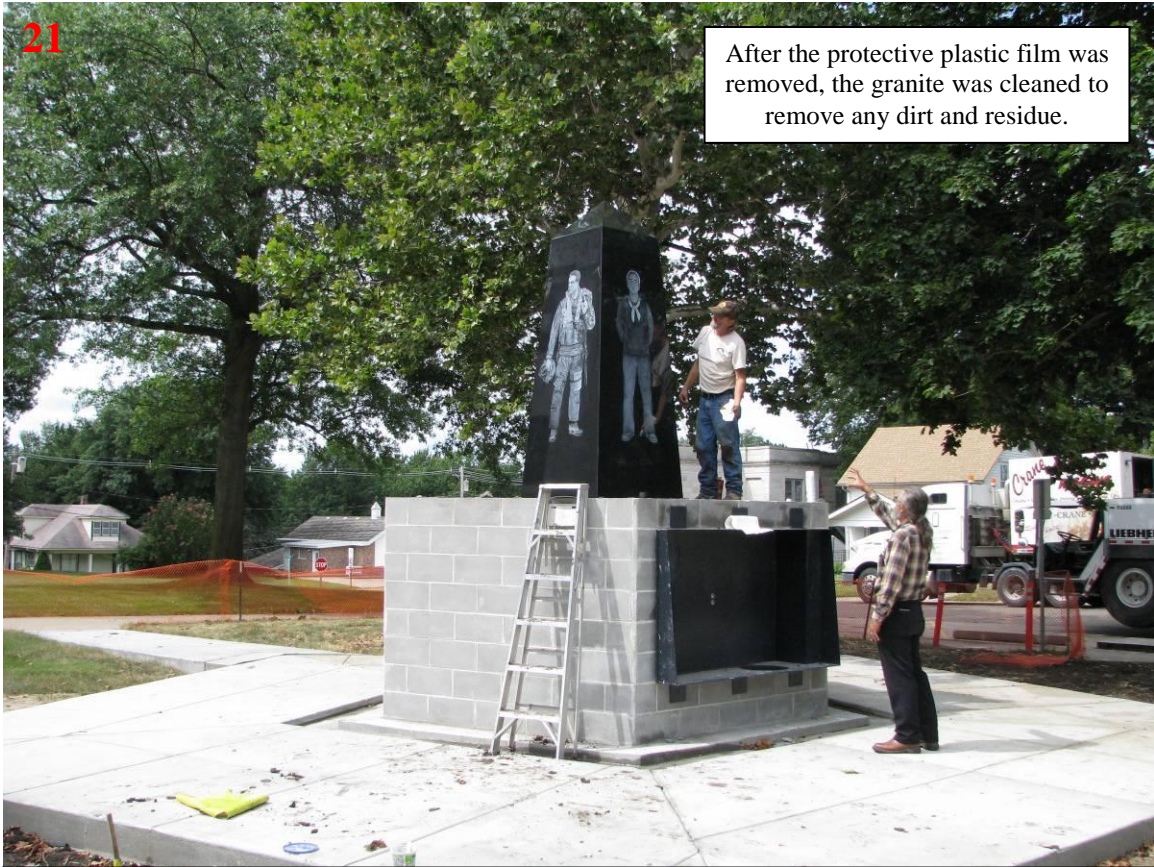
After the protective plastic film was removed, the granite was cleaned to remove any dirt and residue.

View of the granite obelisk from the northeast.
